**Flood Control Project Maintenance
Levee Inspections**

Fall 2009 Levee Maintenance Deficiency Summary Report

Reclamation District No. 0349 Sutter Island

Levee Inspection Report By Mile - Fall 2009

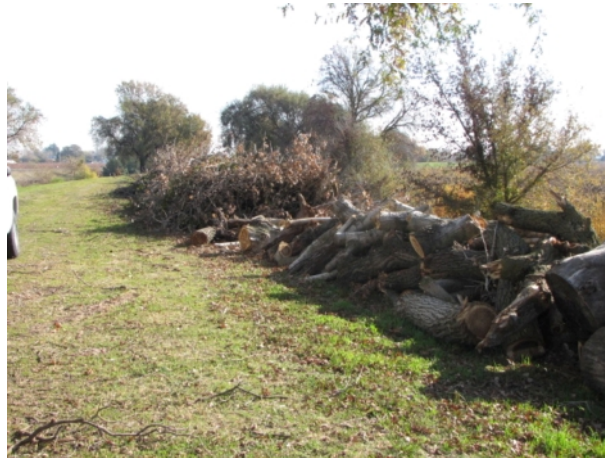
phillips_20091201_16.jpg

7	5.44	5.53	Earthen Levee	Trim / Thin Trees	WS	C	Thin trees to allow visibility of the ground and room to flood fight.	38.323783 ° -121.586260 °	38.324857 ° -121.585360 °	28
8	6.06	6.11	Earthen Levee	Encroachments	LS	M	Tree or limb Inspector Comments: This brush pile needs to be burned or not allowed to remain on the levee section.	38.331563 ° -121.583342 °	38.331460 ° -121.582448 °	973 Y
9	6.39	6.41	Earthen Levee	Encroachments	WS	M	Firewood Inspector Comments: The farmer has declared this section of levee as his burn pile. If he plans to burn then this should be burned or removed from the levee, rodents will start to dig holes under the brush piles.	38.328762 ° -121.578890 °	38.328383 ° -121.578408 °	972 Y

Levee Mile Report Line	8
Start Levee Mile	6.06
End Levee Mile	6.11
Location	Land Side
Category	Earthen Levee
Item	Encroachments

Rather large brush pile on the land ward slope and shoulder.

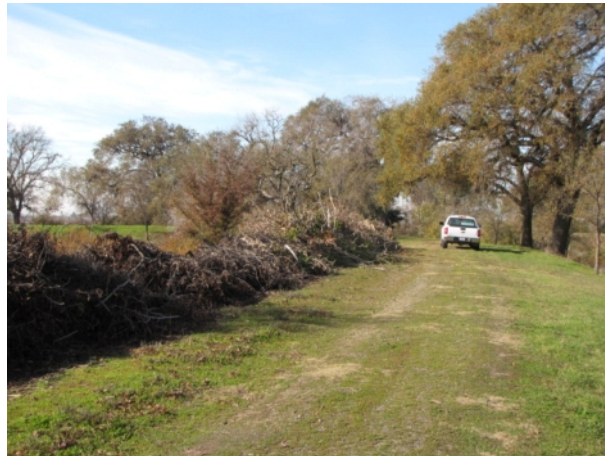
phillips_20091201_17.jpg

Levee Mile Report Line	8
Start Levee Mile	6.06
End Levee Mile	6.11
Location	Land Side
Category	Earthen Levee
Item	Encroachments

view from down stream.

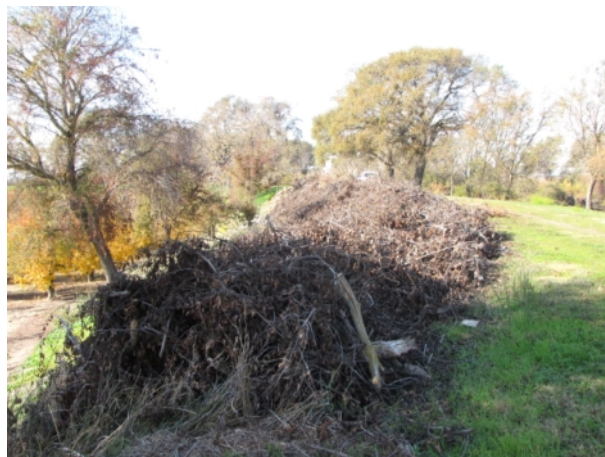
phillips_20091201_18.jpg

Levee Mile Report Line	8
Start Levee Mile	6.06
End Levee Mile	6.11
Location	Land Side
Category	Earthen Levee
Item	Encroachments

Down stream at end of pile landward.

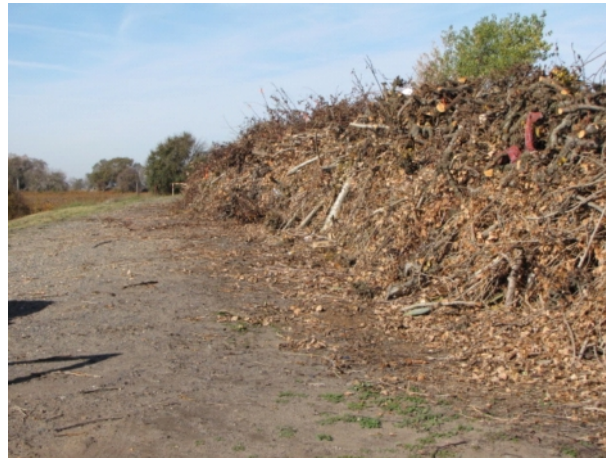
phillips_20091201_14.jpg

Levee Mile Report Line	9
Start Levee Mile	6.39
End Levee Mile	6.41
Location	Water Side
Category	Earthen Levee
Item	Encroachments

Hugh brush pile on the waterward shoulder.

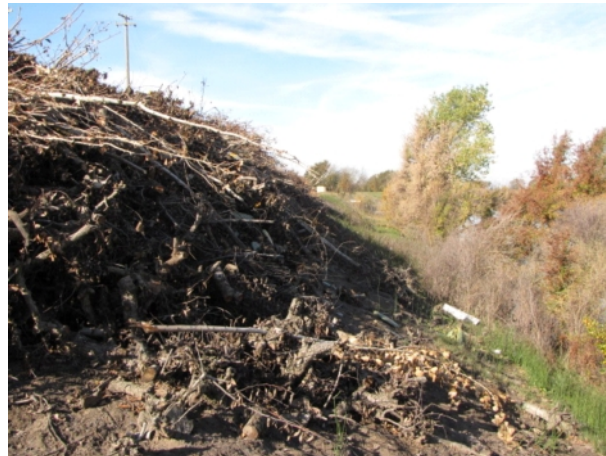
phillips_20091201_15.jpg

Levee Mile Report Line	9
Start Levee Mile	6.39
End Levee Mile	6.41
Location	Water Side
Category	Earthen Levee
Item	Encroachments

View of brush pile waterward shoulder and slope.
